Manhole Inspection Summary

Manhole # S17QQ1021MH

Insp Date: **6/27/07 9:40 AM**

Location Address: **YELLOWWOOD AVE**

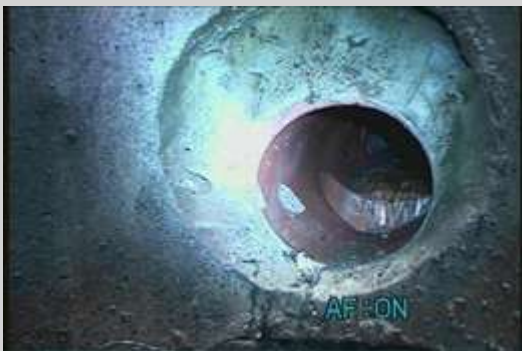
8 in. Circular Gravity Sewer Pipe In @ 8 O'Clock

Rod and Bar (Angled)

Pipe Material: **Clay** ☐ Pipe Lined

Invert Depth: **13.80** (ft.) Flow Characteristics: **Fast**

Deposits: ☒ None ☐ Mud ☐ Sludge ☐ Debris ☐ Grease

Infiltration: **None** Pipe Seal Cond: **Unknown**

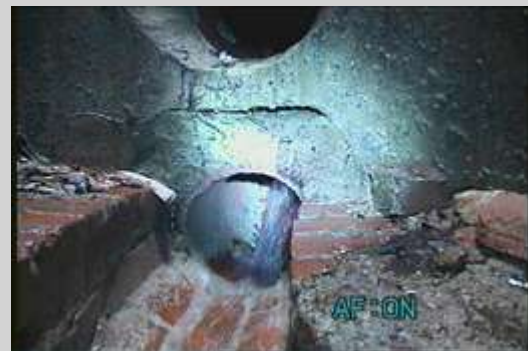
Drop In @ 8 O'Clock

Drop: **Outside** Rod and Bar

Angled: **Yes** Reading: **14.10** (ft.)

Drop Condition: **Open**
